FERNHURST / NORTH PARK

WEALD IRON RESEARCH GROUP

NORTH PARK FURNACE

North Park Furnace, Linchmere

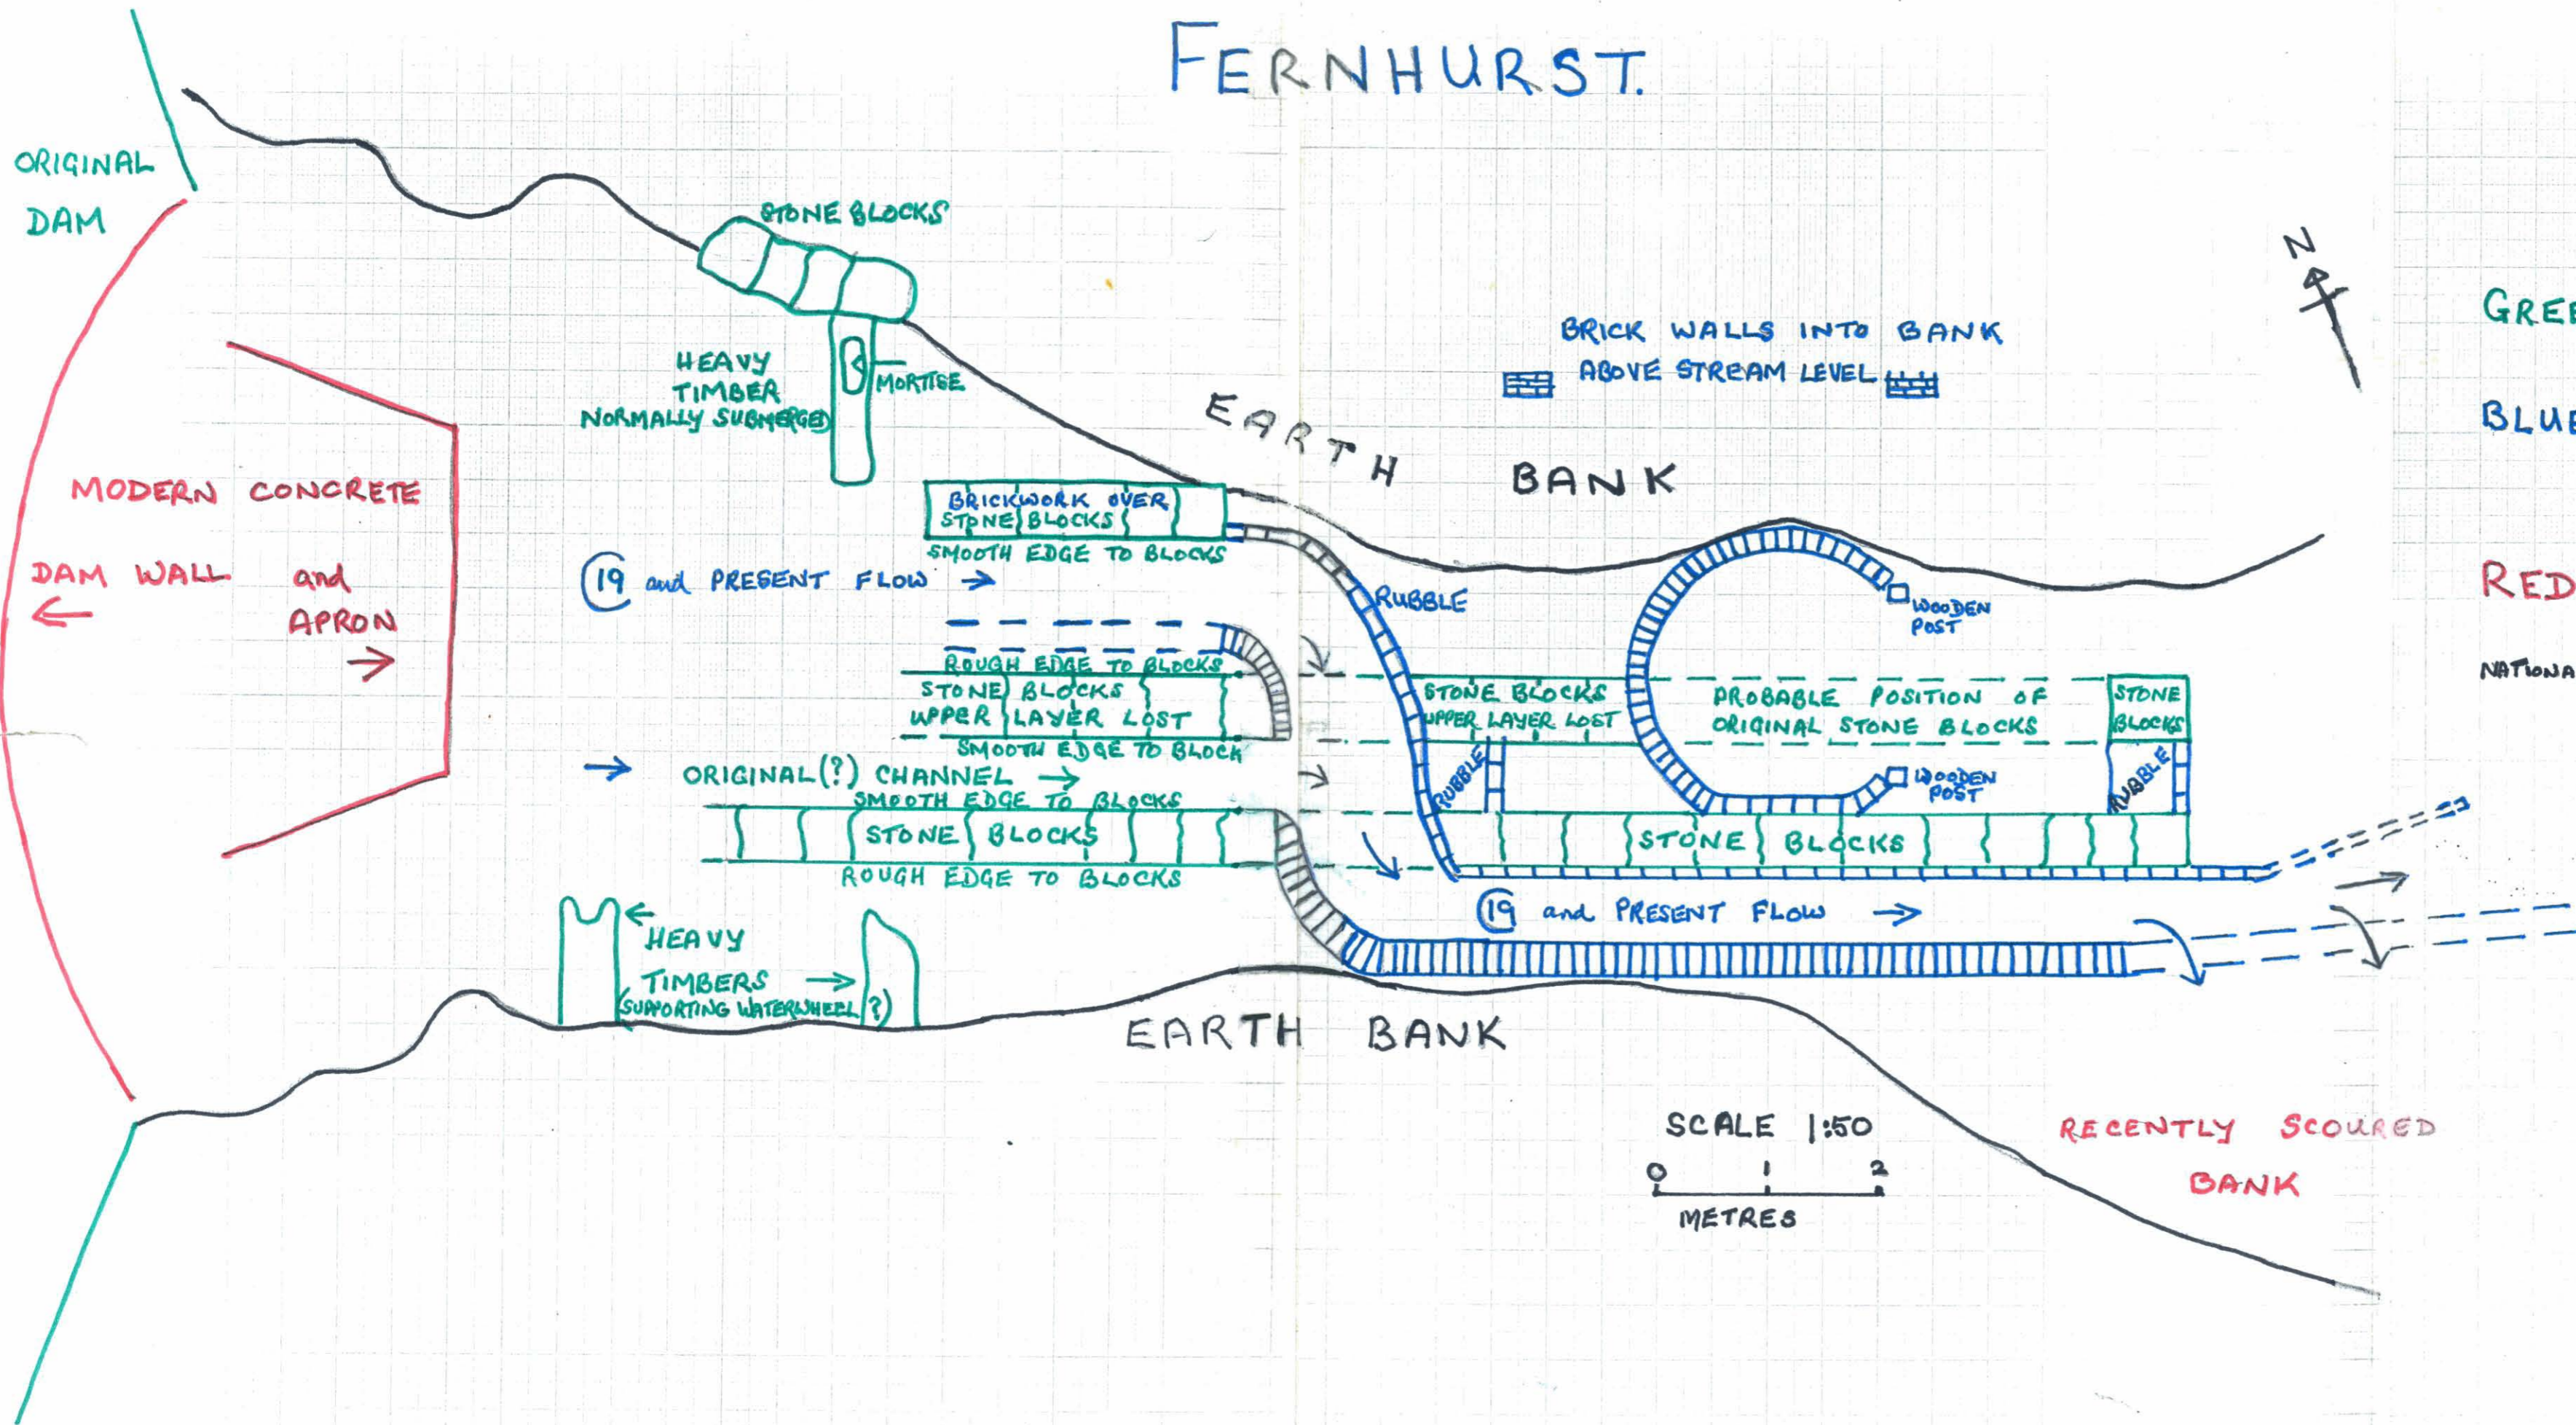
NORTH PARK BLAST FURNACE FERNHURST.

Straker gives, virtually, the correct longitude and latitude for this site, but it is more like $1\frac{1}{2}m$ than $1\frac{1}{4}m$ from Fernhurst Church. The furnace is located at the N end of the bay (Gr. 50870263).

The pond is still in water but at a very much lower level than originally. The disused spillway at the S end has been rebuilt; probably more than once. There are grooves in the lower courses on the pond side but not in the cement-pointed upper courses. (Cp. Straker's photo). The spillway itself is broken through at the lower end. Most of the stone surface has been lost, exposing the cement base and where this also is broken, the undisturbed clay contains sawn-off timber piles. Slag has been used as an infill above this clay. The bay is here faced with sandstone ashlar work. The ditch leading downstream from this plunge-pool cannot be positively traced after the first 50yds.

Between the two plunge-pools a very large slag heap rises to the level of the bay and has been dug away, in part, for road metal (Mrs. Hollist).

At the N end of the bay a modern sluice cuts through and recent floods have caused a large section of the bank to be washed away. Below the plunge-pool a complex of brickwork, partially submerged, is to be seen at low water. Only the downstream extremity of this complex appears to be of any age. Some courses of brick buried in the overhanging S bank are of 17thCent. type. Large sandstone blocks are to be seen at the N edge of the plunge-pool and isolated blocks are scattered high on the N bank where, further downstream, is a hollow flanked by a steep hillock over which fragments of mortar are scattered.

Unconsolidated slag lies thickly along the S bank as far as the footbridge and is approx. 10ft thick in the cliff at the downstream extremity of the brickwork. Here it overlays 2ft or more, of disturbed clay.

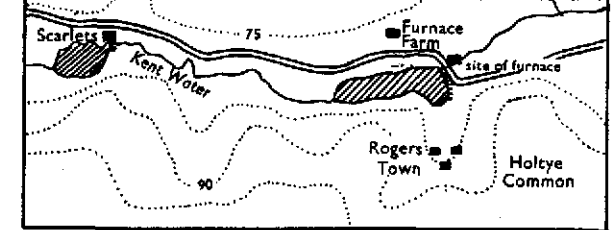
Fig. 5d

metre upstream where there was a forge as well as a furnace (Fig. 5d). The site of the lower furnace remains in the converted mill house below the embankment crossing the valley bottom. The sandstone cliffs around must have been extensively quarried for lining the furnace. The furnace pond forms a fine open stretch of water although at its upper end it has begun to silt up. At Scarlets farther upstream the pond and containing embankment also exists as well as the cottages of the site of the original forge and furnace. Both the upper and lower furnaces were in existence in the sixteenth century, producing iron for making cannons and cannon balls. Many of the latter have been dug up in the area where the works formerly stood. Both the furnaces and forge had ceased to work by the middle of the eighteenth century and although at one time there were considerable slag heaps at Scarlets, these have mainly gone to provide material for road making.
