Report on a Programme of Archaeological Works at Fernhurst Furnace, Fernhurst, West Sussex

September 2022

WEST SUSSEX ARCHÆOLOGY

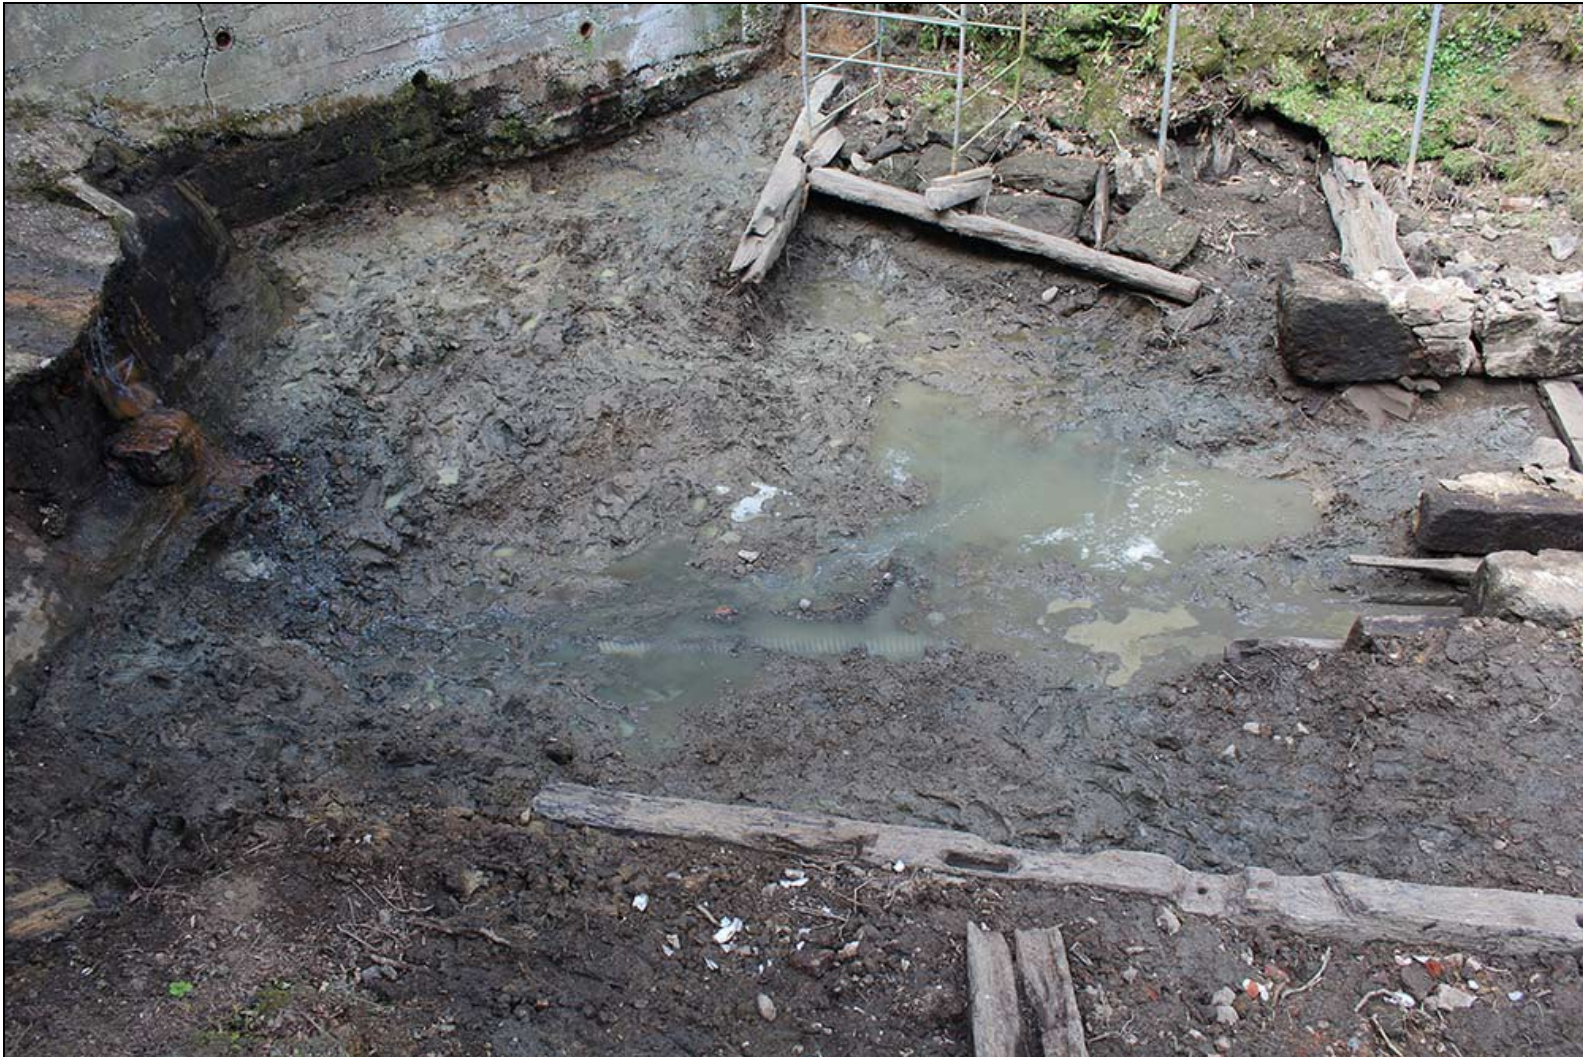
Figure 6 The wheelpit area looking north-east after removal of all the brick and stone debris onto the natural clay

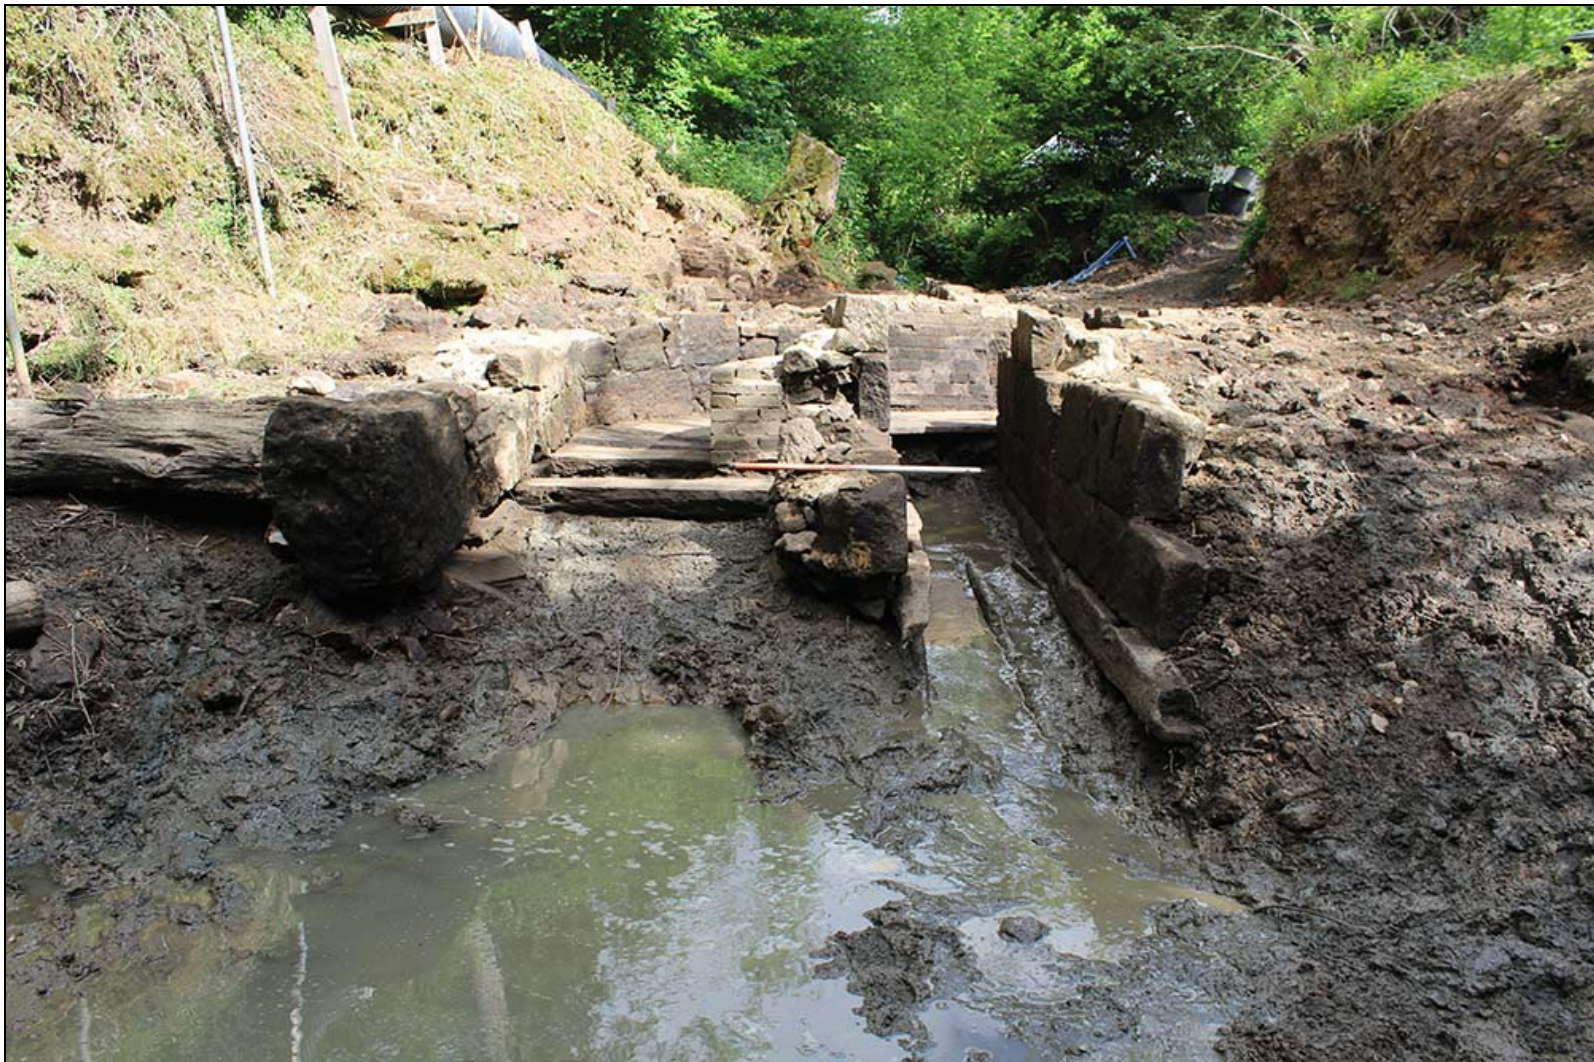
4. A number of changes were noted to the surviving remains from the drawings that had been made in 1989-93, all resulting from subsequent flood events. The most significant had occurred to the series of timbers to the north of the wheelpits, with the loss or burial of a number of timbers, and the movement of two of the surviving three. To the south, a short length of timber associated with the western of the two large beams protruding from the dam had also disappeared. The stone walls of the two extant wheelpits exhibited some alterations, with the ends of the southern and northern walls pushed outwards, and c.0.75m of the central wall completely washed away.

Figure 7 The entrance to the surviving wheelpits, looking south-east, showing the displacement of the outer walls, and the diminished central wall

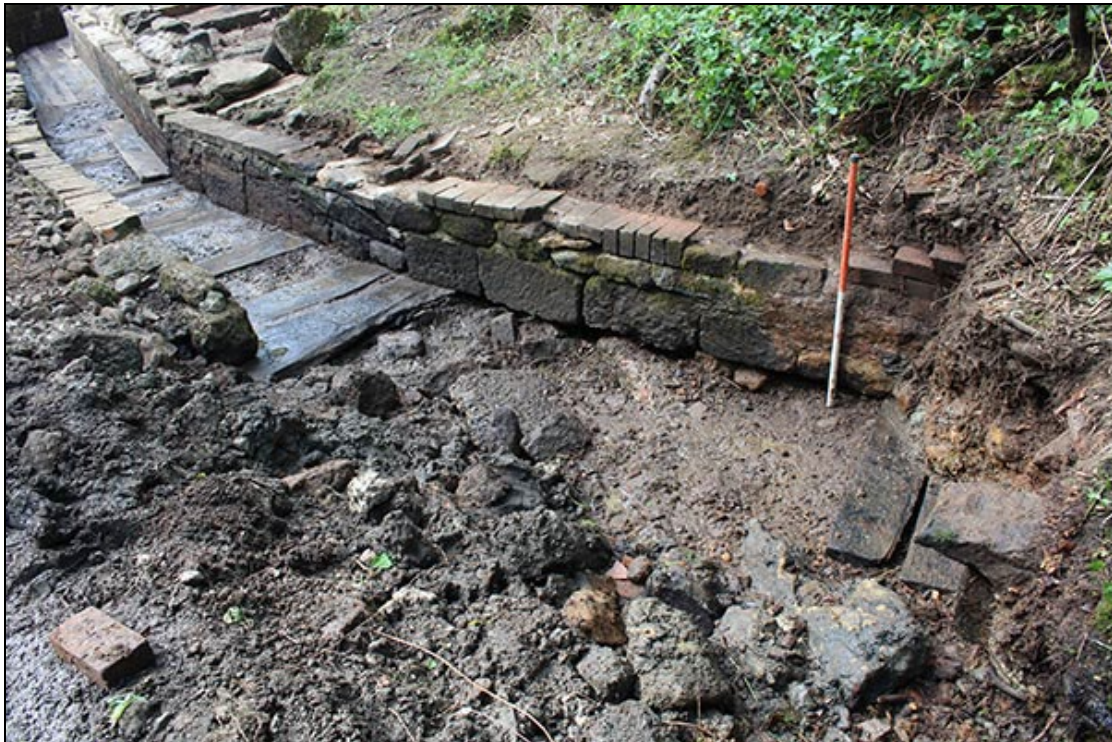
- As a result of erosion since the 1989-93 works, a further length of the tail race was exposed at its eastern end, indicating that it once continued beyond the existing bend in the stream, its course now covered by the slumped southern bank.

Figure 8 The east end of the tail race, to the right it continues into the slumped bank.

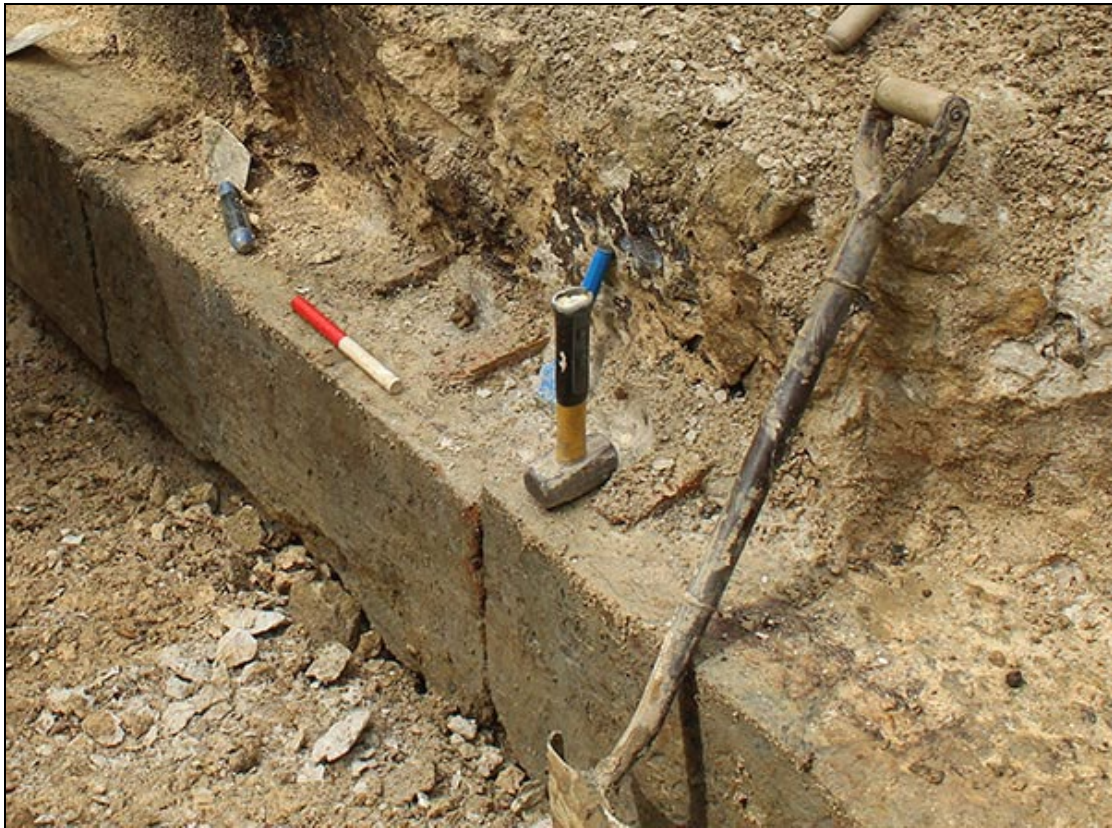
that width. It would appear that the laying of the facing stones themselves began at the inner ends of the wall, adjacent to the backing to the pre-existing wing walls, and then progressed outwards, since at both outer ends the final stones are often irregular or do not fit with the overall coursing; presumably laid to suit whatever gap was left between the wall and the neighbouring bank or dam as cut back for the works. Wooden wedges had occasionally been used to level up individual facing stones (see Figure 11).

Figure 11 Three wooden wedges in the main east wall of the spillway

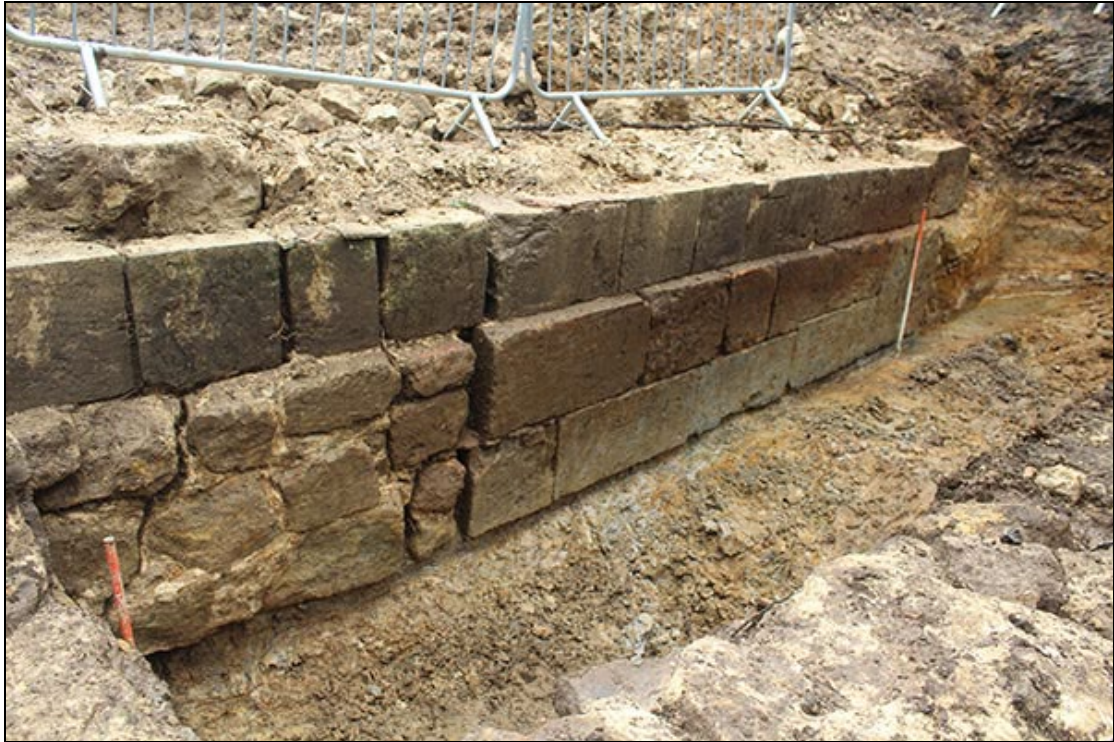
4. The section of wall to the north of the arch, at its lowest level, was cut into the underlying Wealden clay, but at the height of its third course was then cut into the base of the dam, here composed of re-deposited Wealden clay containing some fragments of slag, clearly indicating that the stonework post-dates not only the formation of the dam, but also at least its early use for the iron works. The wall itself, at its base, extends 6.5m to the north of the inner north face of the barrel vault, increasing to 8.5m at the top. As stated above, it was faced with dressed Lower Greensand blocks, with the single exception of a block of masonry at its southern end, 1.5m wide and 0.8m high, butting up to the backing of the northern wing wall (see Figure 12). This section was composed of irregularly shaped Lower Greensand blocks set in a significantly greater amount of lime mortar. It is not clear why this should be, although it is possible that there were not enough of the larger stones used exclusively in the lowest two courses.

Figure 12 The lowest courses of the north end of the main east wall of the spillway, showing the undressed section of wall in the foreground

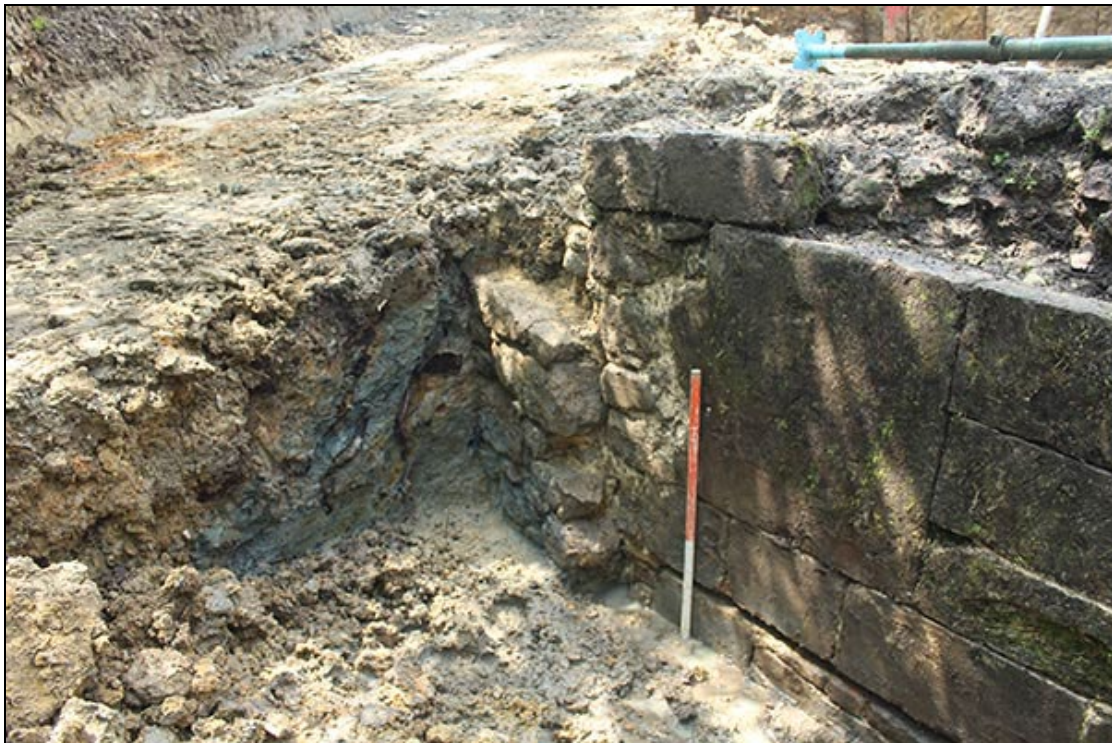
9. The southern wing wall consisted of four courses of Lower Greensand ashlars, with the lower three courses of similar dimensions to those on the north side, the upper being of the 23cm thickness (see Figure 16). As with the north side a double height stone flanked the spillway. A difference on this south side, however, was that two larger stones, one double height and another triple height, were included within the coursing. In addition the south end of this wall was made up of undressed and uncoursed stones set in lime mortar, rather than the usual ashlars. This may be due to the presence of an earlier stretch of wall against which the wing wall butted. Only a fragment appeared to remain of this earlier wall, just 0.75m north-south, with its top 0.5m below that of the adjacent wing wall and projecting c.0.15m to the east of it (see Figures 13 & 17). It was composed of undressed and uncoursed Lower Greensand rubble set within a lime mortar of a deeper yellow colour than the wing wall. It would appear to pre-date the wing wall and be cut by it, and may be all that remains of an earlier facing to the dam, possibly supporting a previous phase of spillway.

Figure 17 The remains of the earlier wall adjacent to the southern wing wall on the eastern side of the spillway, looking south-west

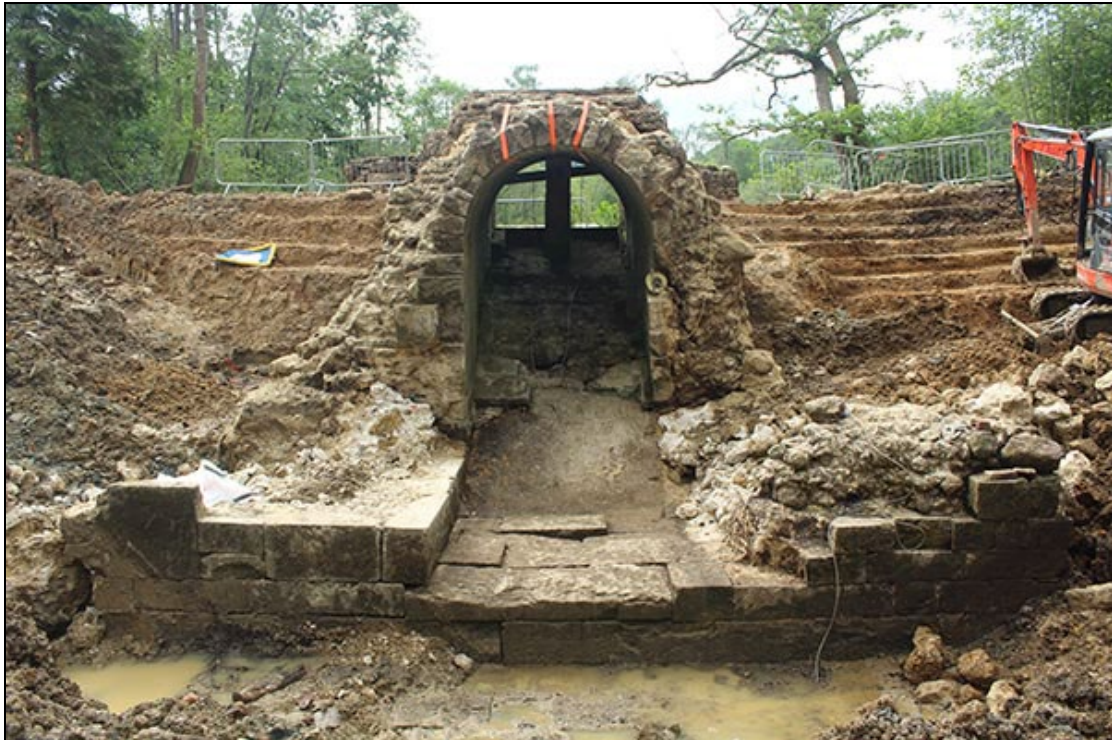
10. Stretching across the whole width of the wing walls, and forming the base to the spillway, was a single course of Lower Greensand ashlars, c.0.26m thick, below which further courses lay to an unknown depth. The stones forming the base of the spillway itself had been worn down by c.6cm, presumably through the agency of the water flowing over them, with the mortar beneath also washed away, causing them to drop onto the course below (see Figure 19).

Figure 19 The spillway looking west, showing the remaining slabs at its base

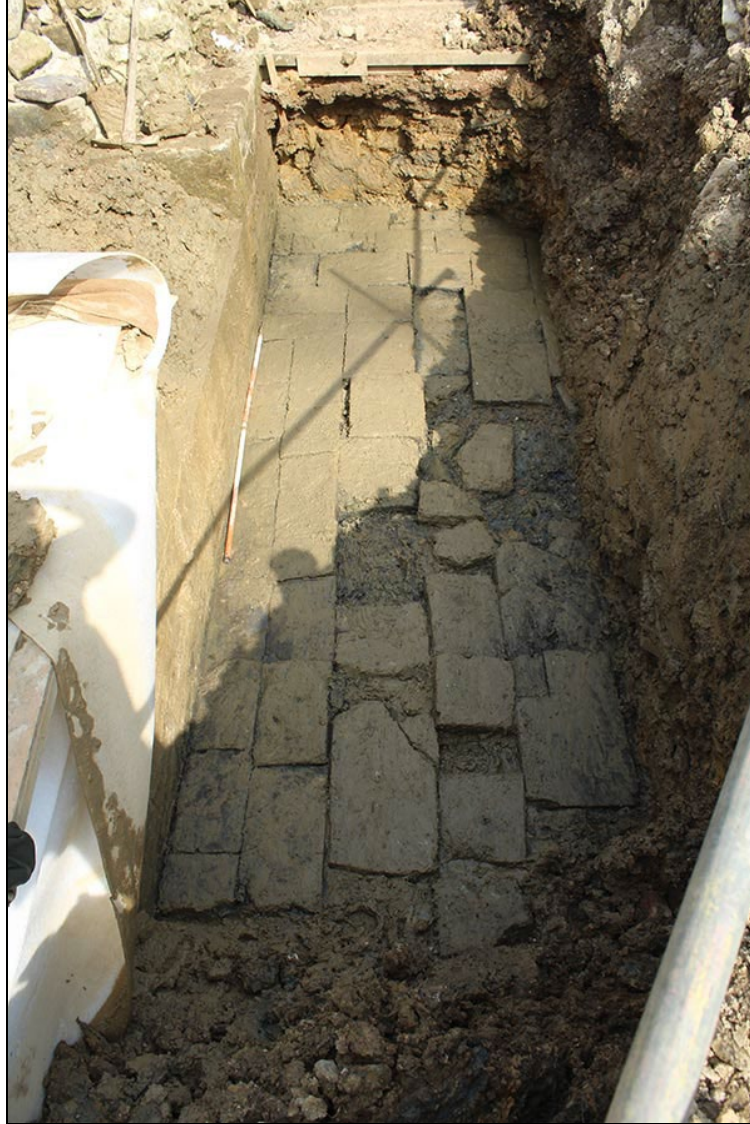
12. To the east of the wings walls an apron composed of Lower Greensand slabs was recorded, extending c.1.5m to either side of the spillway, c.2m to the east and lying 0.7m below the level of the spillway's eastern lip (see Figure 20). A number of its slabs were missing or disarranged, presumably as a result of uncontrolled water flow.

Figure 20 The stone apron to the east of the spillway, looking north

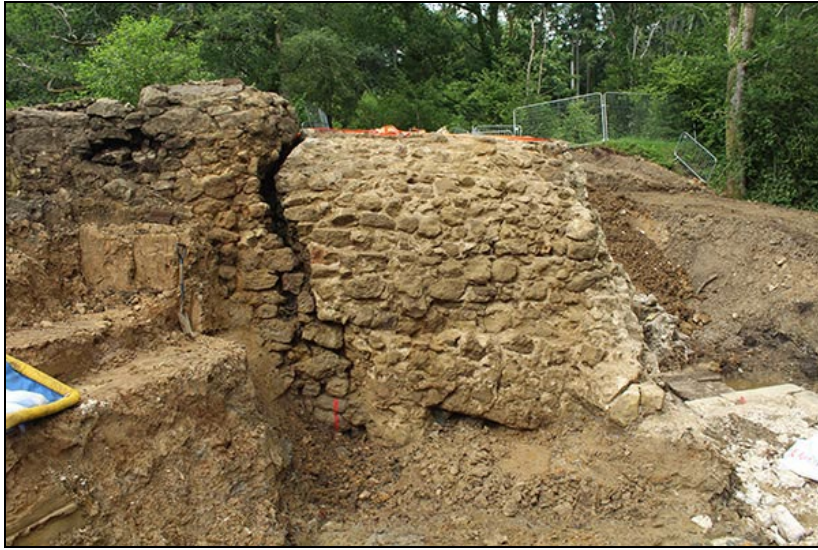
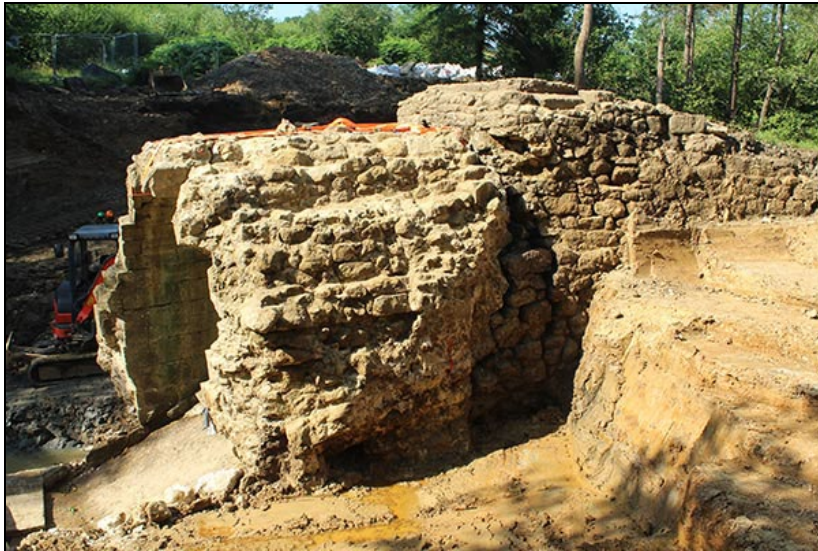
13. The dam between the east and west facing walls was composed of clay at its core, but this had clearly been supplemented at a later date with slag, either mixed in with clay or alone, and dumped on the outer and upper surfaces of the original clay dam. The barrel vault through the dam was constructed in the same manner as the outer walls of the dam, with inner facing stones of dressed and coursed Lower Greensand blocks backed by uncoursed and undressed lower greensand stones set in a pale yellow mortar (see Figures 21 & 22). Its two sides were stepped at least once as it sloped from west to east. At both its ends it was found to have separated from the outer walls, with large cracks extending from top to bottom.

Figure 21 The exterior of the barrel vault, looking north

Figure 22 The exterior of the barrel vault, looking south-west
