# MAYFIELD IRONWORKS WADHURST PARK ESTATE EAST SUSSEX

## CORE MONUMENT RECORD & TOPOGRAPHIC SURVEY OF THE IRONWORKS SITE

Final Report

July 2014

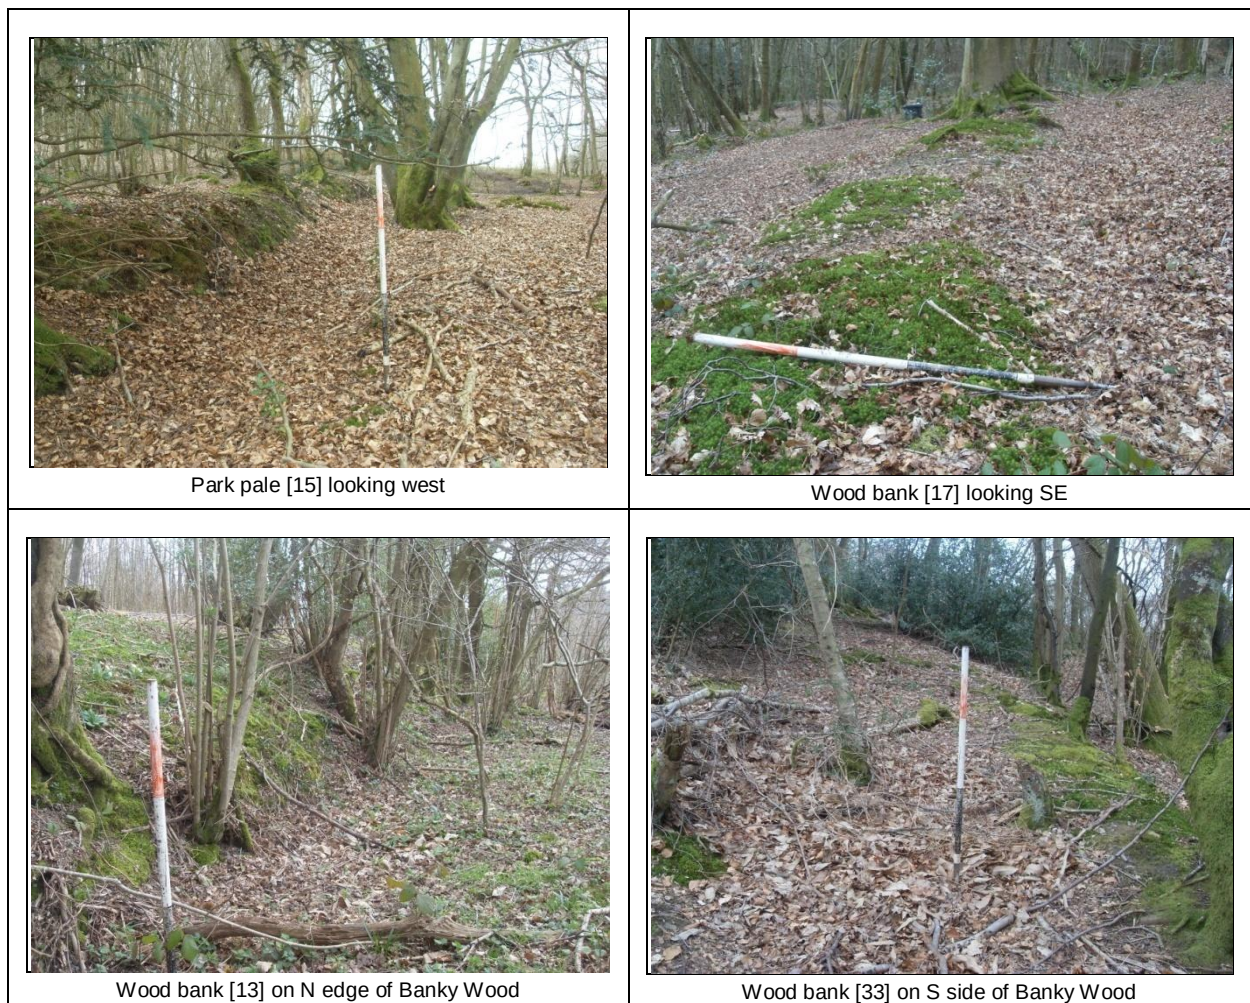
*Figure 5. Boundary earthworks*

The wood banks are in good condition and lie well-preserved within the woodland. Wood bank 17 shows evidence of vehicles having been driven over it in the past, possibly when Brickhurst Wood was clear-felled. The management guidance for these sites are:-

- b. Avoid taking any wheeled or tracked vehicles over the earthworks.
- c. If it is unavoidable, select one area, cover with plenty of brash and confine access to this one point. Afterwards carefully remove the brash. Consider any necessary work to be done in the summer when the ground conditions are dry but avoid the bird-nesting season.
- d. If extraction of timber is considered using a horse/s and sledge/and or skid etc. undertake extraction works during conditions when the ground is dry, as hooves can easily poach the soft clayey soils.
- e. Avoid erecting any new fencing on the earthwork, to avoid damaging any below ground old ground surfaces and also avoid any new tree planting on the earthwork.
- f. Manage burrowing animals using humane methods but which avoids digging into the earthwork.

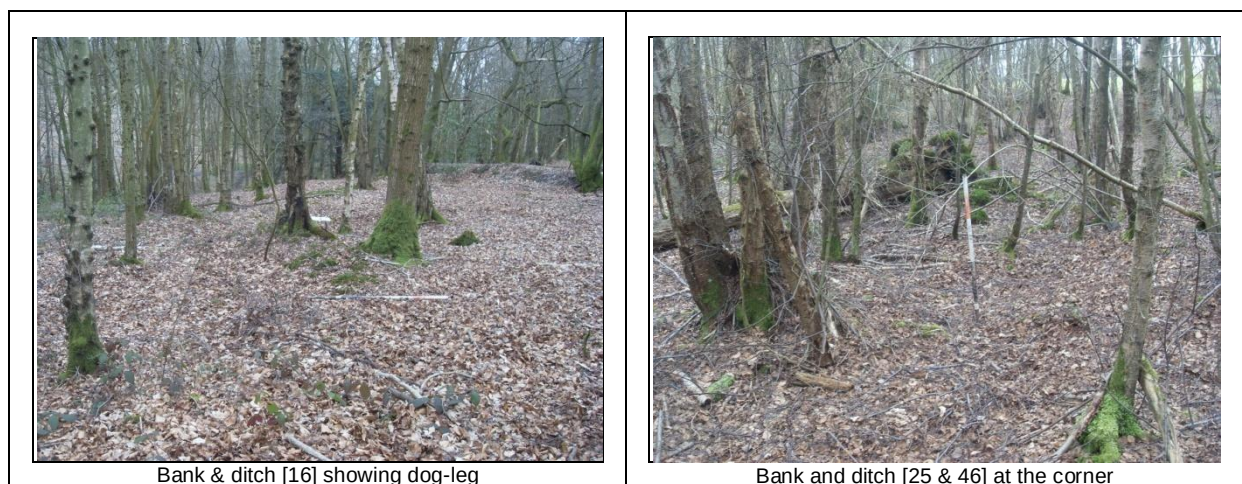
*Figure 6. Bank & Ditches*

These banks are in good condition and lie well-preserved within the woodland. However their dimensions are very slight and would be easily overlooked during active woodland management. Further such features may have been sited in former Brickhurst Wood to the south but any such slight features appear to have been destroyed when the wood was clear-

- c. Avoid taking any wheeled or tracked vehicles over the earthworks.
- d. If it is unavoidable, select one area, cover with plenty of brash and confine access to this one point. Afterwards carefully remove the brash. Consider any necessary work to be done in the summer when the ground conditions are dry but avoid the bird-nesting season.

- e. If extraction of timber is considered using a horse/s and sledge/and or skid etc. undertake extraction works during conditions when the ground is dry, as hooves can easily poach the soft clayey soils.

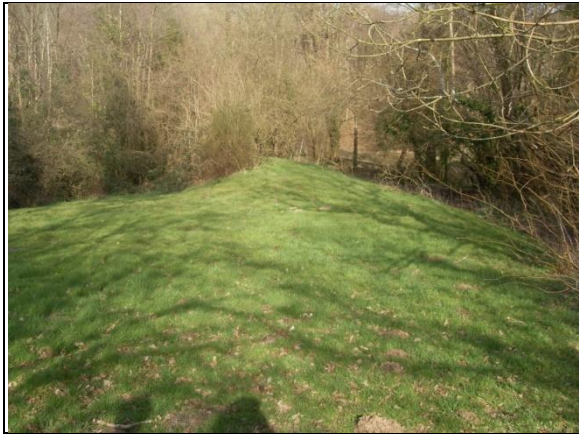
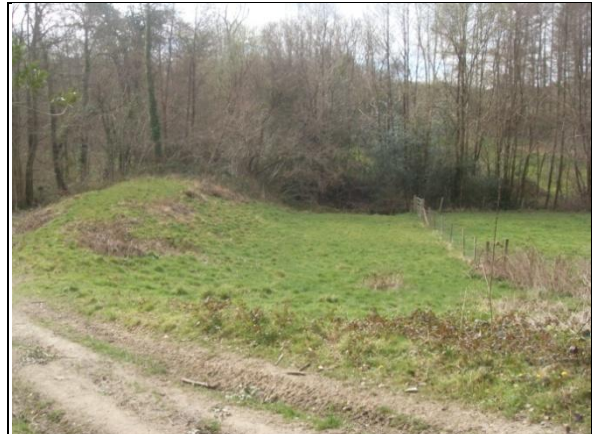
Three of the six sites lie well preserved in coppice woodland. They have been breached to allow the pond to drain and the streams to flow. Where the water flows through the bays the earthworks of the bays are gradually being eroded by the streams, exposing roots and the earth/clay core of the dams. The over-stood coppice on the boring mill pond bay [02] has been cut back in the winter (2013-2014) revealing the earthwork and reducing the threat of wind throw. However the coppice on the other two [06, 04] remains and the threat to wind-throw is high. It is recommended that the over-stood coppice on the bay [06] for the boring mill pen pond is reduced in height. The bay between the upper and middle ponds is not within the ownership of Wadhurst Park Estate.

Pond bay to main pond looking N [01]

Pond bay to main pond looking S [01]

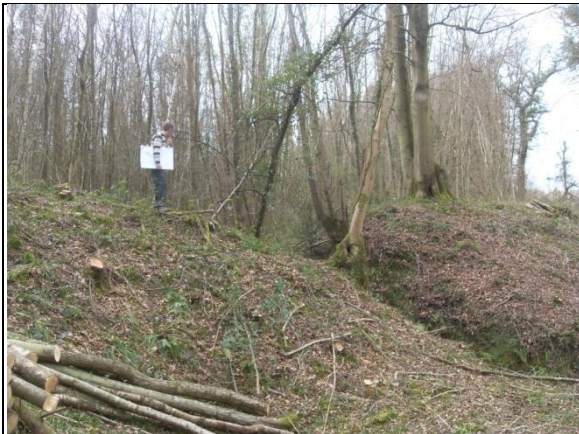
Boring mill pond bay [02]

Only the boring mill pond and its pen pond lie within the Wadhurst Park Estate ownership. The sites are undisturbed within mature coppice. The coppice should be managed to prevent it becoming over-stood. But cutting should be undertaken by hand and especially when the ground conditions are favourable i.e. not wet. Vehicles should not be used for extracting the timber.

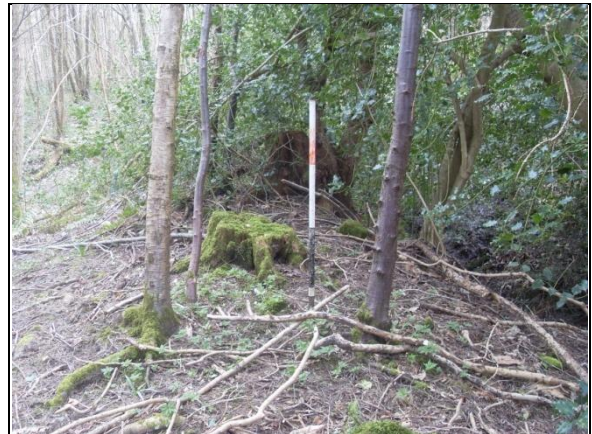
Boring Mill pen pond bay[06]

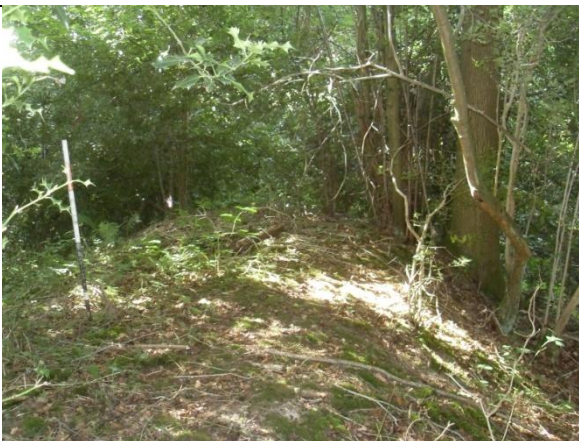
Pond bay to Upper pond in Furnace Wood [04]

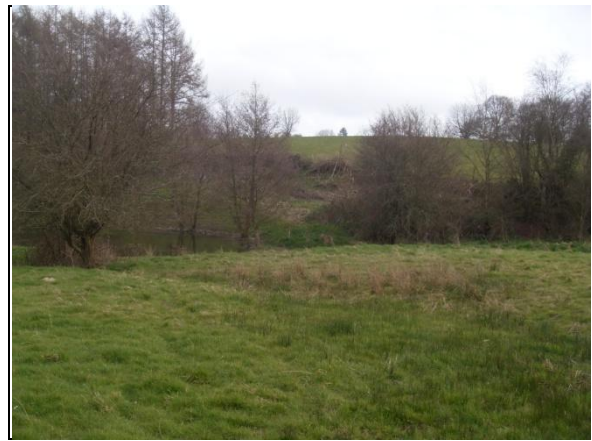
Pond bay on tributary stream [03]

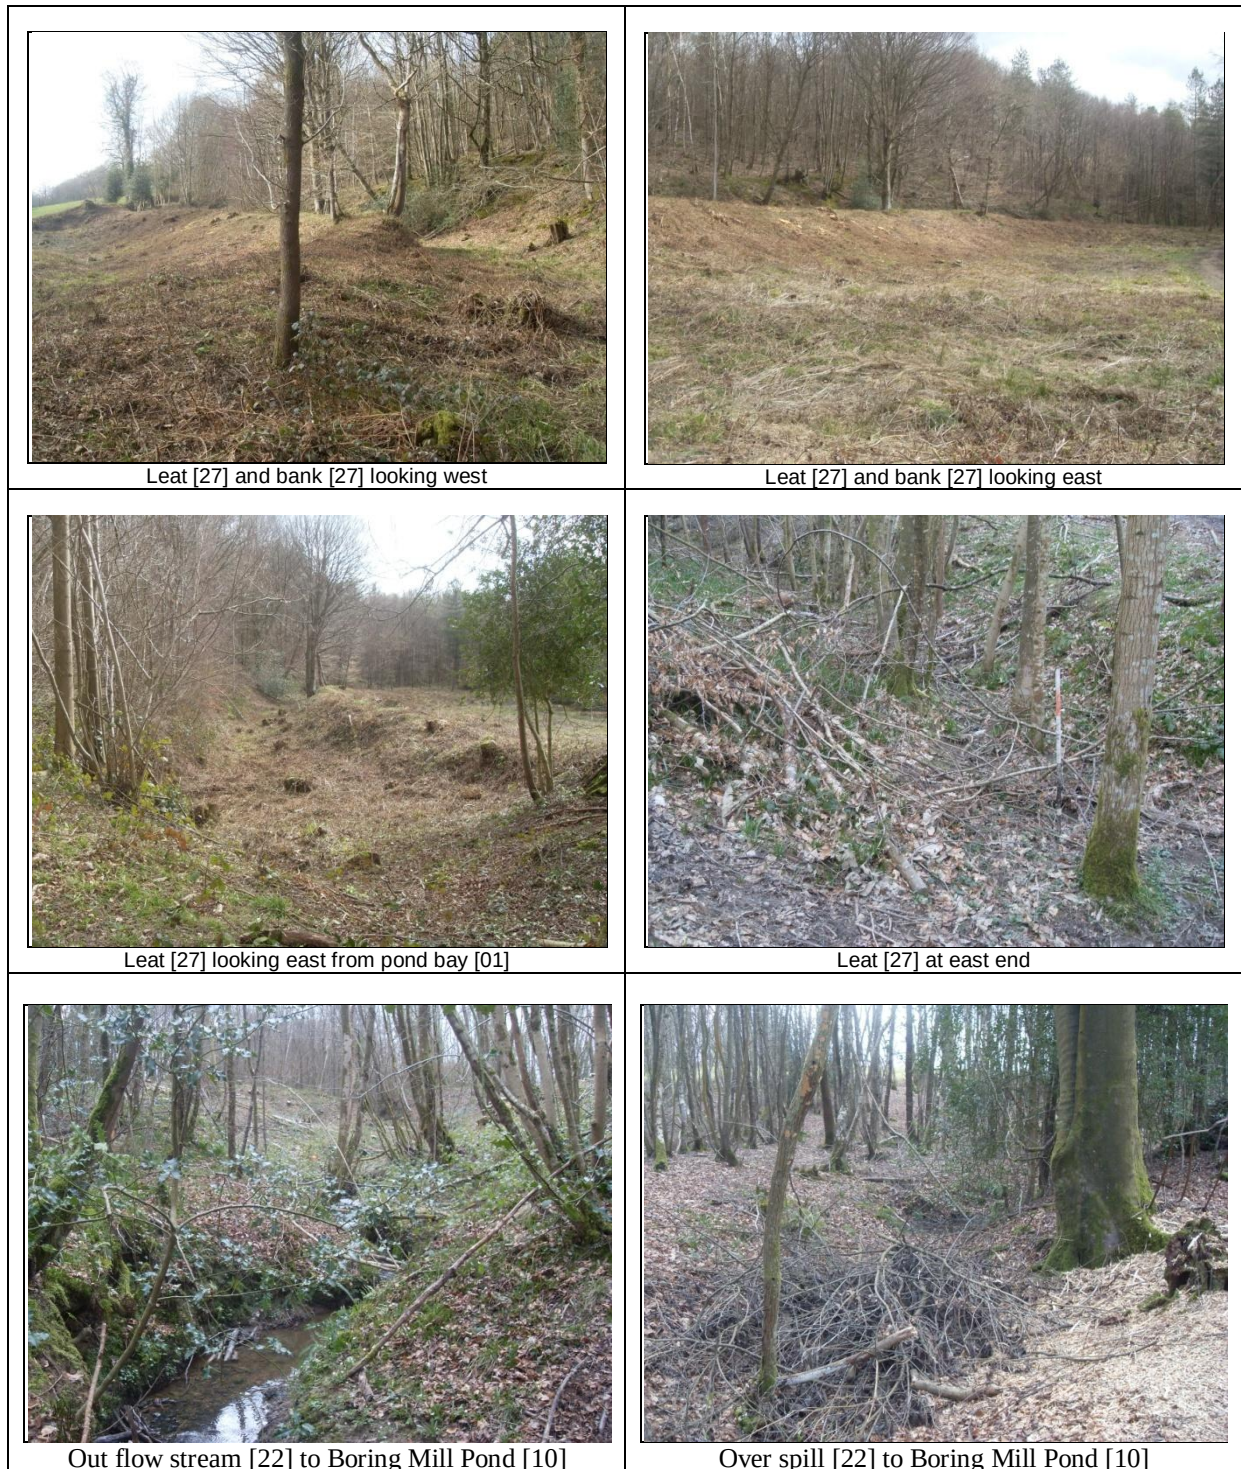
*Figure 9. Water courses across and through the site*

The main gill stream is in part eroding its banks in places and undermining the public footpath. This will need to be addressed in the future and possibly an archaeological watching brief set up prior to and during the repair works.

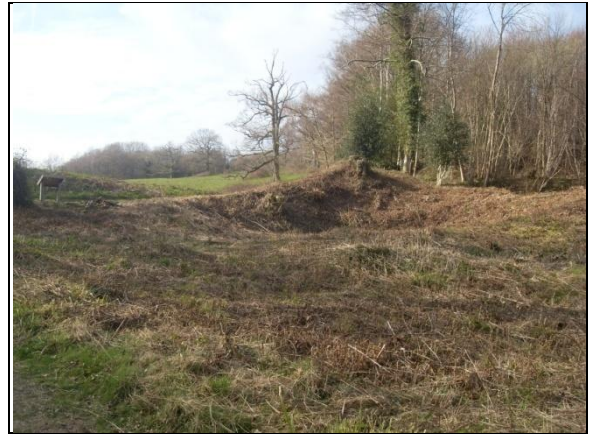
Site of possible second furnace [42]

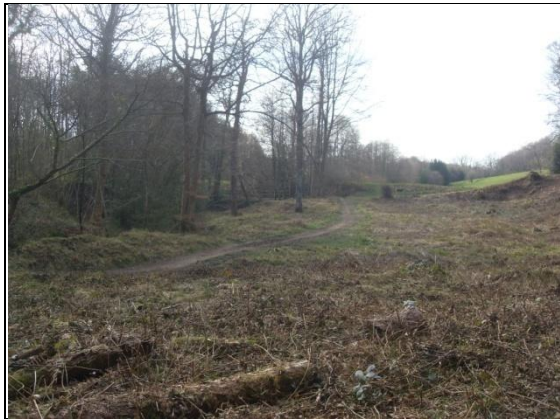
| Number | GIS Grid Reference centred | Scheduled | Description | GPS Grid Reference | Description of Position |
|---|---|---|---|---|---|
| 43 | TQ 5926028137 | Yes | Site of furnace damaged by bridge | | |

The site of the furnace is of national significance despite the damage already caused by the construction of the bridge. There is likely to still remain extensive below ground archaeology surviving at this site and also across the whole area enclosed by the bank of the leat. The possibility of a second furnace site is especially interesting.

Furnace site from bank to leat looking NW [43]

The part of the site of the furnace is traversed by the public footpath which is well used and gets very muddy in wet conditions. The whole area was cleared in February 2014 of scrub and flailed to a height of about 0.2m in order to facilitate this survey. It is managed as an open area within woodland to encourage song birds, flora and invertebrates. Ideally this should continue. The erosion on the footpath needs to be managed in order that it does not spread into adjacent areas during very wet conditions.

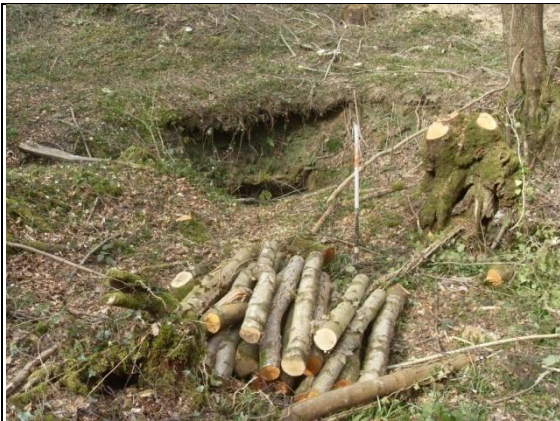
Site of wheel pit for boring mill [44]

The site is of high national significance and importance. Its relationship with the furnace site and its role in the history of ordnance working are the key factors. The undisturbed nature of the site means that below ground features are likely to survive in a good condition.

As with all heritage features minimal disturbance is important. Avoid siting extraction routes over or near this site, avoid disposing of brash on it and avoid stock piling timber or wood on it. In the future also avoid any replanting over it. Management of the coppice should be undertaken when the ground conditions are suitable.

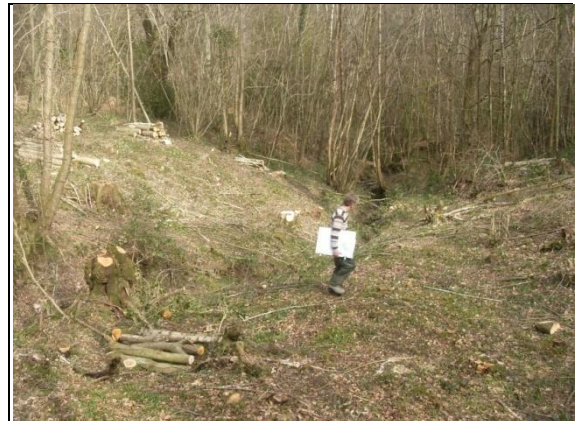
Boring mill [44] area after clearance work
