Report on a Programme of Archaeological Works at Fernhurst Furnace, Fernhurst, West Sussex

September 2022

WEST SUSSEX ARCHÆOLOGY

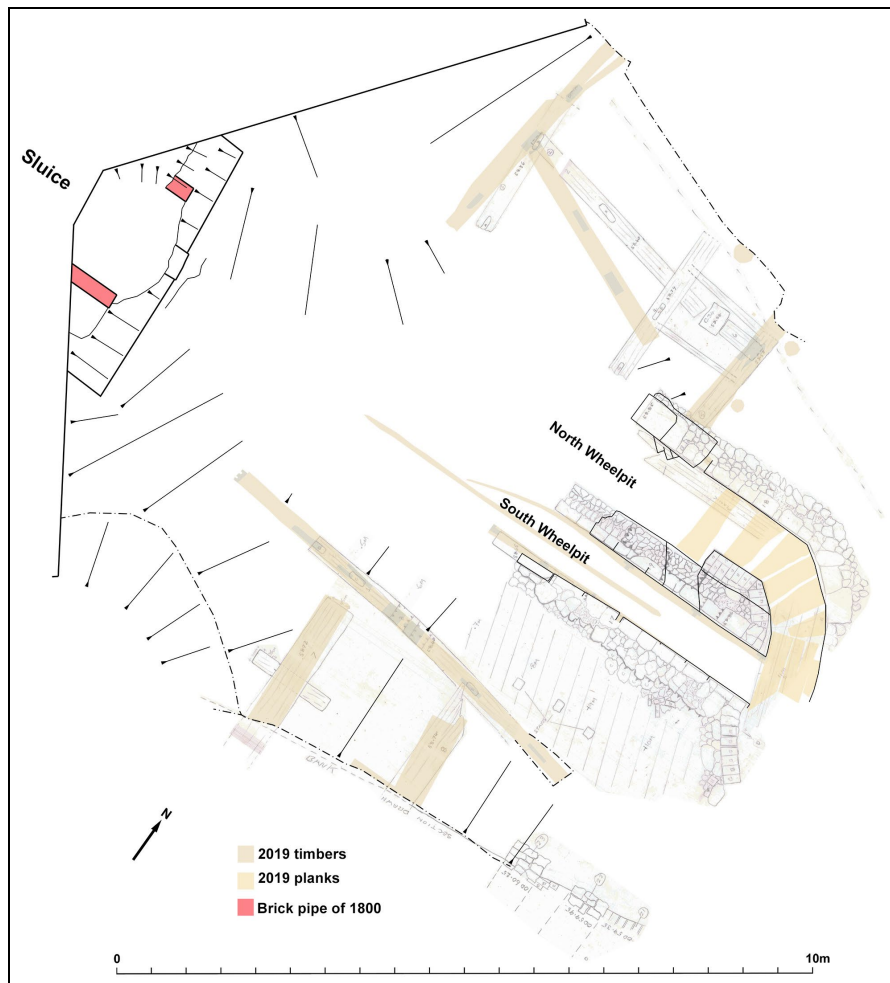
Figure 5 Plan of the sluice works

4. A number of changes were noted to the surviving remains from the drawings that had been made in 1989-93, all resulting from subsequent flood events. The most significant had occurred to the series of timbers to the north of the wheelpits, with the loss or burial of a number of timbers, and the movement of two of the surviving three. To the south, a short length of timber associated with the western of the two large beams protruding from the dam had also disappeared. The stone walls of the two extant wheelpits exhibited some alterations, with the ends of the southern and northern walls pushed outwards, and c.0.75m of the central wall completely washed away.

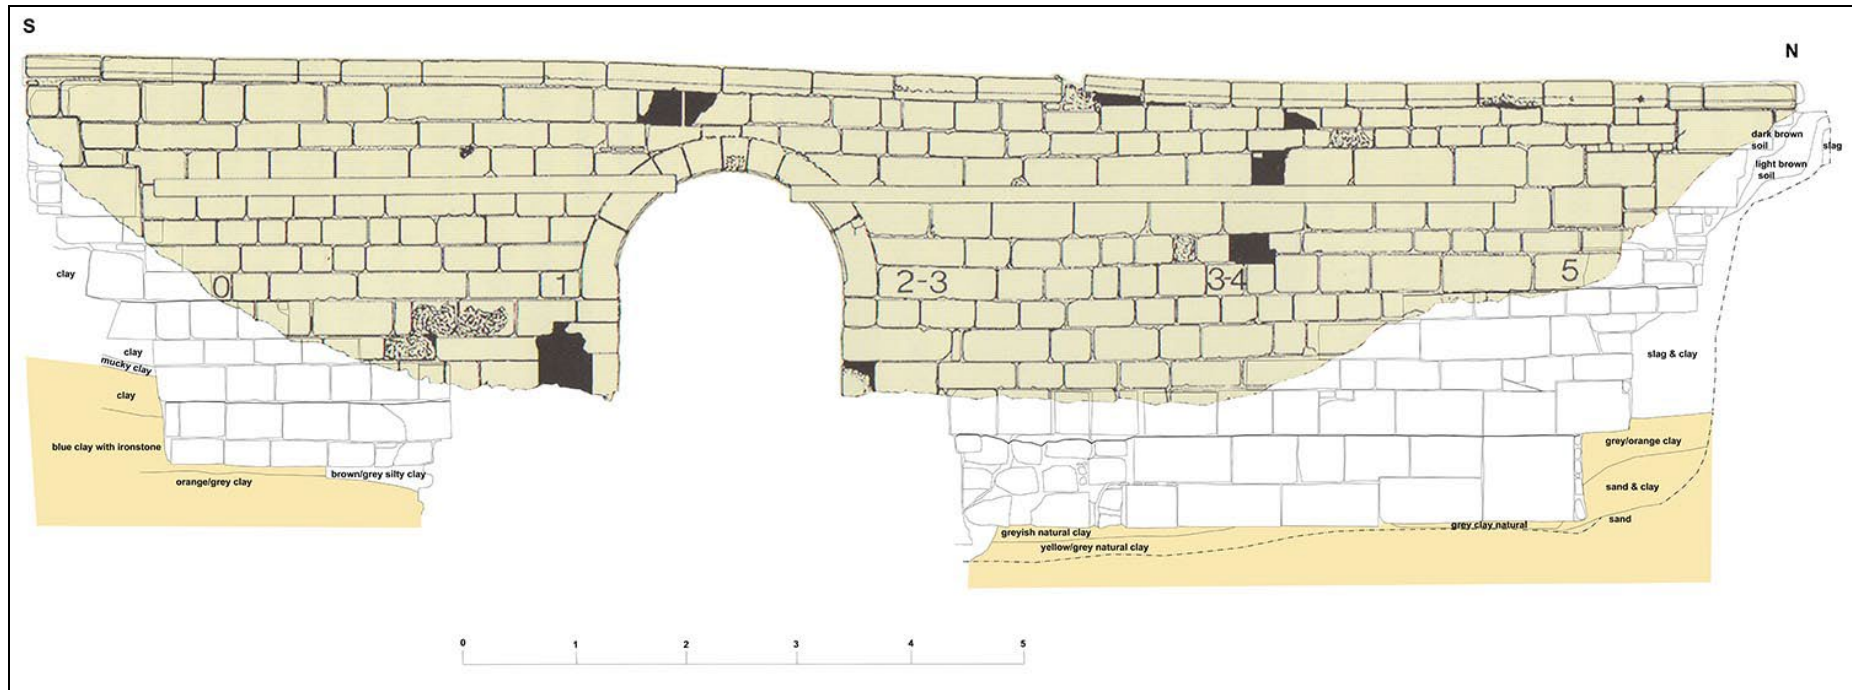
Figure 9 The eastern main wall of the spillway, with the stonework recorded in 2021 added to that drawn in 1989-93

2. The main east wall, composed entirely of Lower Greensand stones, holds the opening to the tunnel vault through the dam, which inevitably splits the wall into two parts below the level of its arch, effectively after the top two courses of the wall. The upper course, which drops noticeably as it passes northwards over the arch, is composed of coping stones, chamfered on their outer edge. The coursing does not form a true level until just below the top of the arch, at the base of the third course, a level it retains for only one more course after which the two sections either side of the arch diverge. The base of the northern section of the wall lies 0.55m lower than its southern counterpart, reaching a total height of 3.9m, whereas the southern is only 3.61m high, rising to 0.26m above the northern end. Despite this difference in height both sides contain thirteen courses, ranging in height from 0.22 – 0.4m. With the exception of a small section immediately adjacent to the rear of the northern wing wall, the facing stones are all well dressed and range in width from 0.3 – 1.2m.

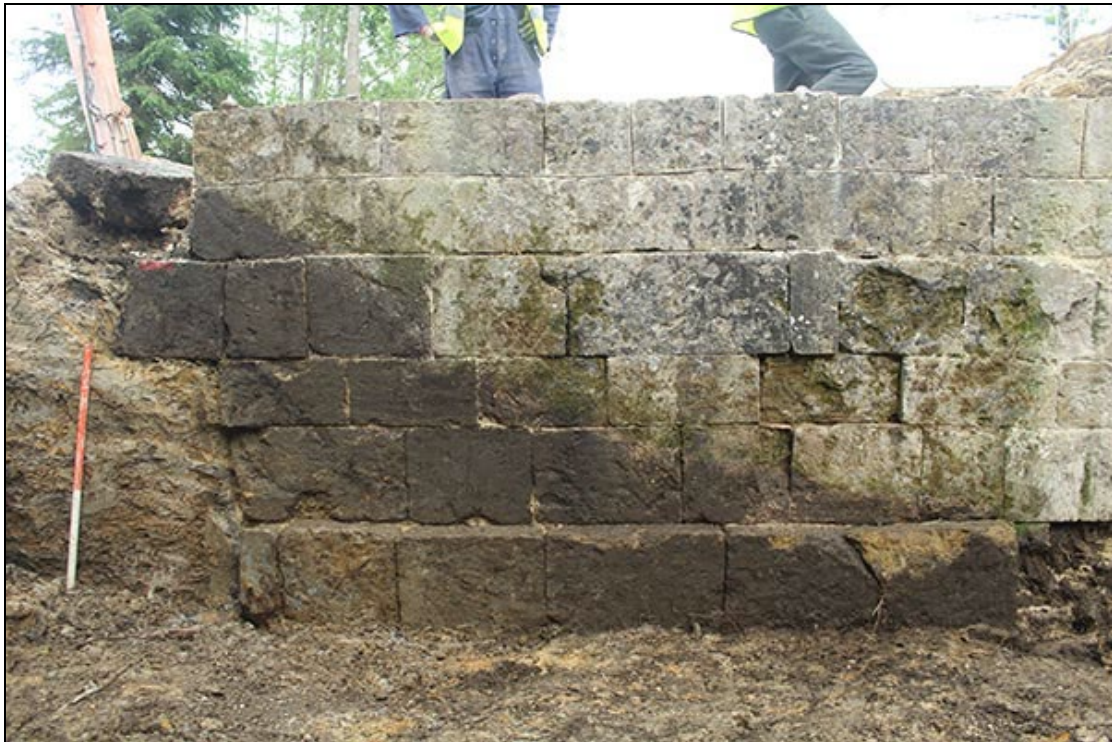
Figure 10 The upper step in the main east wall of the spillway at its southern end

3. As the wall progresses upwards, it steps back twice on the front face, each time by less than 10cm. The first of these steps, on both sides of the arch, was at the top of the second course, as counted from the base of the wall. The second was at the top of the sixth course on the northern side, and the top of the fifth on the southern (see Figure 10). Due to the difference in starting heights, the first step was uneven, but the second, although on different courses, was near to being consistent along the whole length of the wall. The overall wall thickness, as a result of these steps, increases from c.0.7 - 0.75m at the top to c.0.8 – 0.85m at the base, but with the facing stones making up less than half

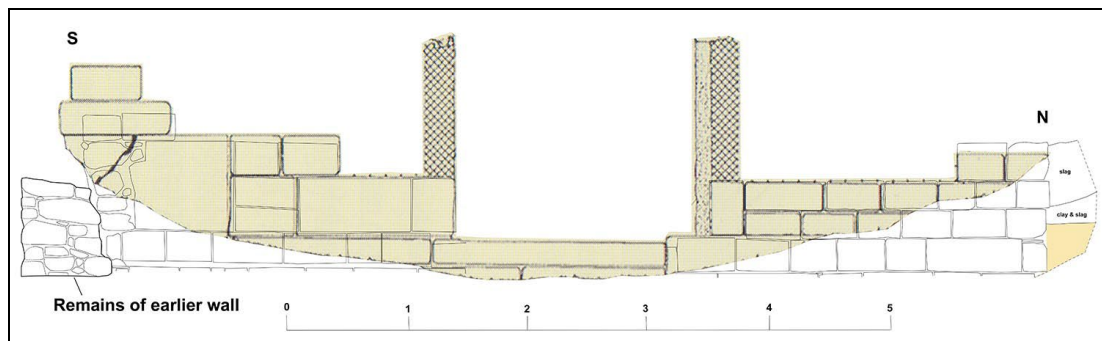
Figure 13 The eastern wing walls of the spillway, with the stonework recorded in 2021 added to that drawn in 1989-93

6. The eastern wing walls began as continuations of the barrel vault's north and south walls before turning north and south as the spillway terminated. The wing walls, and indeed the barrel vault, had clearing been constructed after the base of the spillway since the latter extended beneath. The northern wing wall was c.1m thick as it ran eastwards, and then 1.35m thick after its turn to the north, with its outer face lying 3m east of the main wall (see Figure 14). The southern wing wall was c.1.5m wide as it ran eastwards, and then tapering from 2.64m to 2.05m wide as it ran southwards, with its outer face 2.9m from the main wall. The reason for the significant difference between the thickness of the two wing walls is unknown, although it is possible that an earlier void was being infilled, possibly linked to a previous phase of spillway.

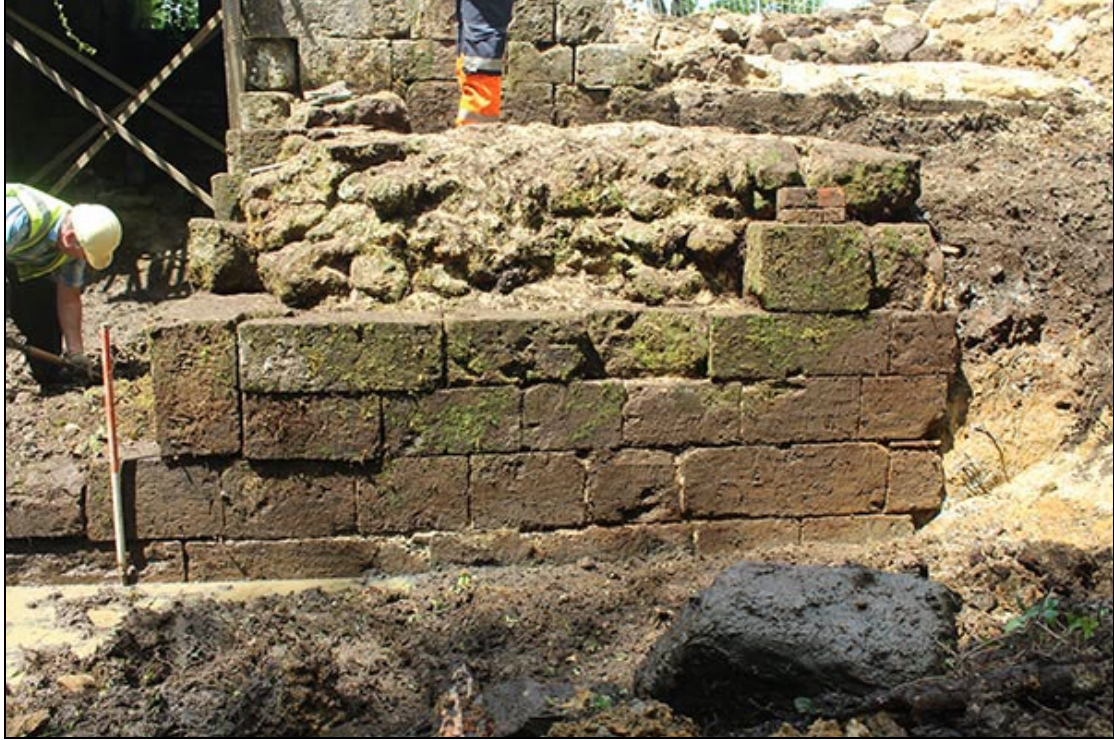
Figure 15 The north wing wall on the eastern side of the spillway

7. Both wing walls were composed of dressed Lower Greensand blocks for their facing stones, behind which was a backing of undressed and uncoursed Lower Greensand set in lime mortar. The base of neither wall was exposed during these works. Both wing walls originally extended to six courses high above the level of the east end of the spillway, but on their front faces over half of this has been lost. Presumably having been washed away or robbed.
8. The north wing wall extended c.2.8m to the north of the spillway, while the south wing wall extended c.3.1m. The former, above the level of the spillway, consisted of three courses of Lower Greensand ashlar, although only two stones remained of the top course (see Figure 15). The stones of this upper course were 30cm thick, whilst those of the

lower two courses were only 23cm thick; the length of all varied between 0.28 – 0.68m. The exception to this being at the southern end of this wing wall, where the stone lining the spillway was of double height, spanning the lower two courses. As with the main dam wall to the west, the wing wall was cut into the Wealden clay.

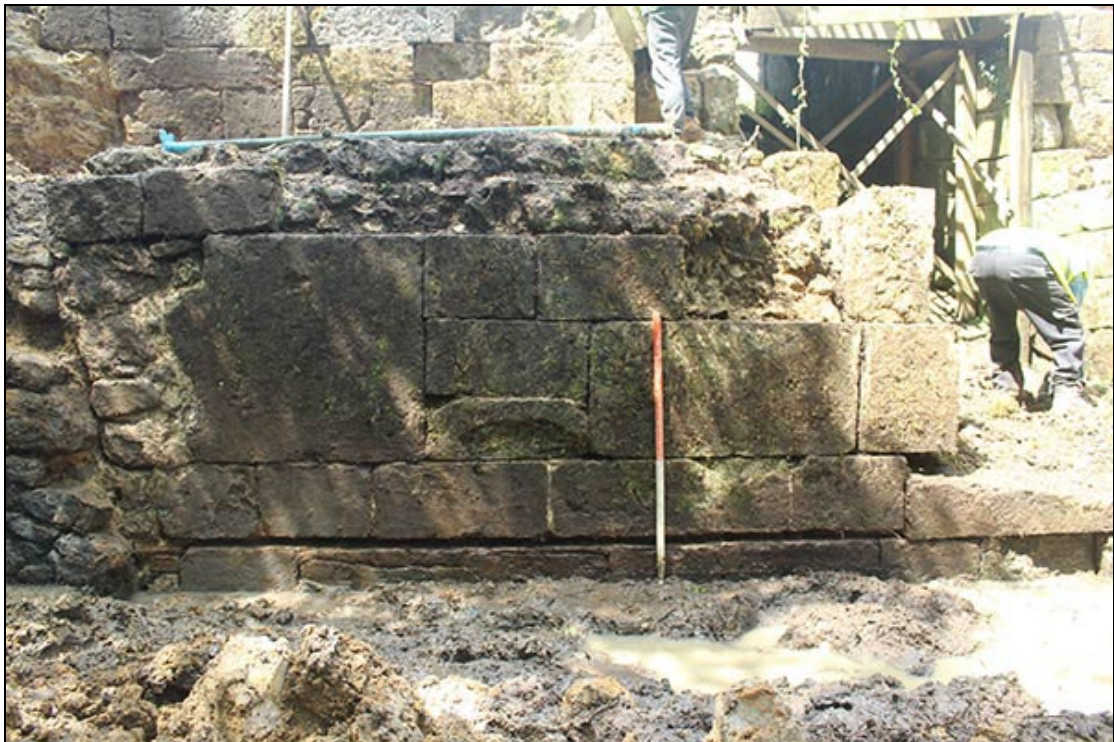
Figure 16 The south wing wall on the eastern side of the spillway

9. The southern wing wall consisted of four courses of Lower Greensand ashlars, with the lower three courses of similar dimensions to those on the north side, the upper being of the 23cm thickness (see Figure 16). As with the north side a double height stone flanked the spillway. A difference on this south side, however, was that two larger stones, one double height and another triple height, were included within the coursing. In addition the south end of this wall was made up of undressed and uncoursed stones set in lime mortar, rather than the usual ashlars. This may be due to the presence of an earlier stretch of wall against which the wing wall butted. Only a fragment appeared to remain of this earlier wall, just 0.75m north-south, with its top 0.5m below that of the adjacent wing wall and projecting c.0.15m to the east of it (see Figures 13 & 17). It was composed of undressed and uncoursed Lower Greensand rubble set within a lime mortar of a deeper yellow colour than the wing wall. It would appear to pre-date the wing wall and be cut by it, and may be all that remains of an earlier facing to the dam, possibly supporting a previous phase of spillway.

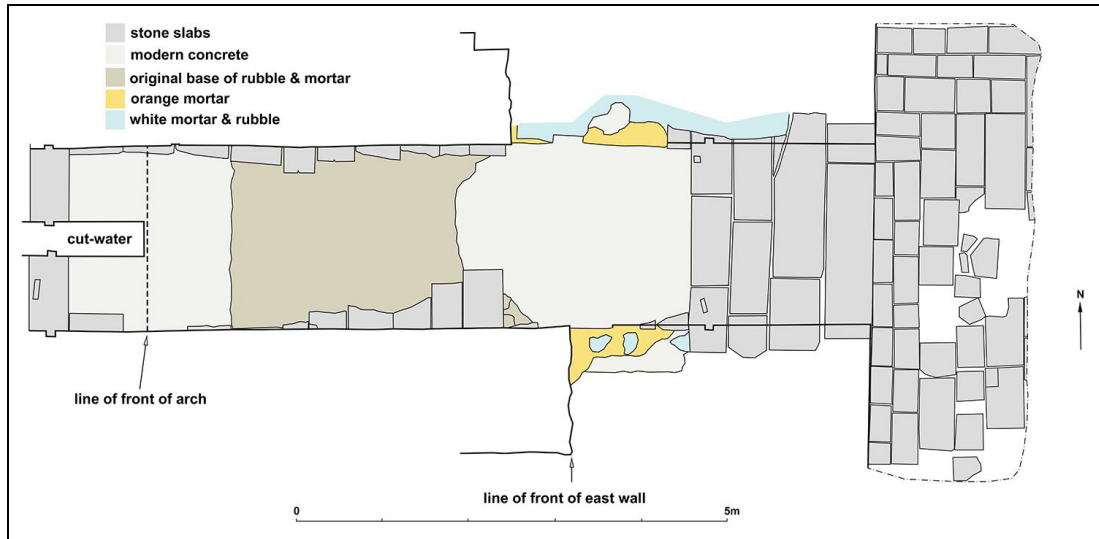
Figure 18 The base of the spillway and its apron

10. Stretching across the whole width of the wing walls, and forming the base to the spillway, was a single course of Lower Greensand ashlars, c.0.26m thick, below which further courses lay to an unknown depth. The stones forming the base of the spillway itself had been worn down by c.6cm, presumably through the agency of the water flowing over them, with the mortar beneath also washed away, causing them to drop onto the course below (see Figure 19).

11. The base of the spillway, as noted above, seems to have been the first element to have been built, with the barrel vault and facing walls placed on top. It was originally composed of stone rubble with Lower Greensand slabs laid above (see Figures 18 & 19). These sloped down from west to east, before levelling out to a flat platform beyond the vault's eastern end. Many of the stones within the sloping section have now been lost, which has clearly caused significant erosion of the rubble beneath, a problem countered in the later 20th century by pouring concrete into the voids beneath.

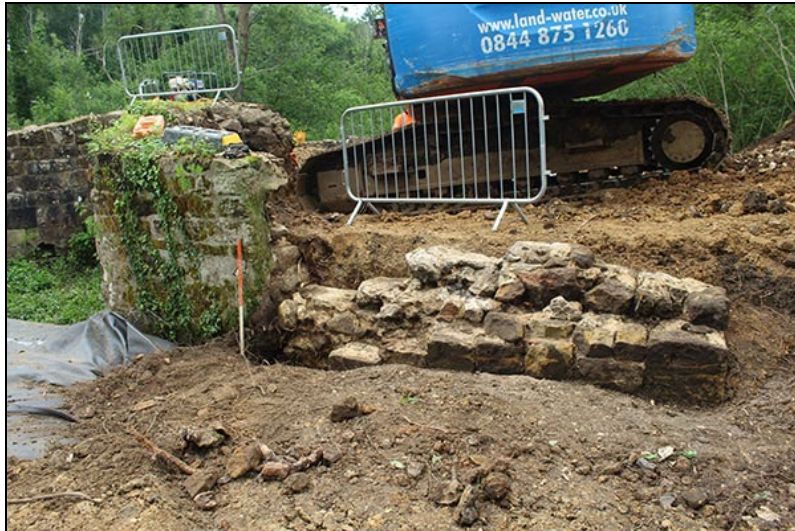
Figure 23 The southern of the western wing walls to the spillway, looking east

14. The western end of the barrel vault is set back from the outer stone wing walls of the dam, the latter previously thought to extend only a short distance to the north and south. However during these works their original length was revealed, hidden beneath undergrowth and topsoil. It can now be seen that they broadly mirrored the eastern dam wall, extending the same distance to the south and north of the spillway (see Figures 4, 23 & 24). It had previously been noted during the 1989-93 work that this western wall shows evidence for a significant reconstruction, and it would seem that these repairs were undertaken on a narrower compass than the original, with the newly revealed stretches of wall clearly being considered not worth repairing. Unlike the replacement walling, they are constructed in the same fashion as the eastern wall, with dressed and coursed Lower Greensand ashlar fronting a rubble backing set in pale yellow mortar.
