# MAYFIELD IRONWORKS WADHURST PARK ESTATE EAST SUSSEX

## CORE MONUMENT RECORD & TOPOGRAPHIC SURVEY OF THE IRONWORKS SITE

Final Report

July 2014

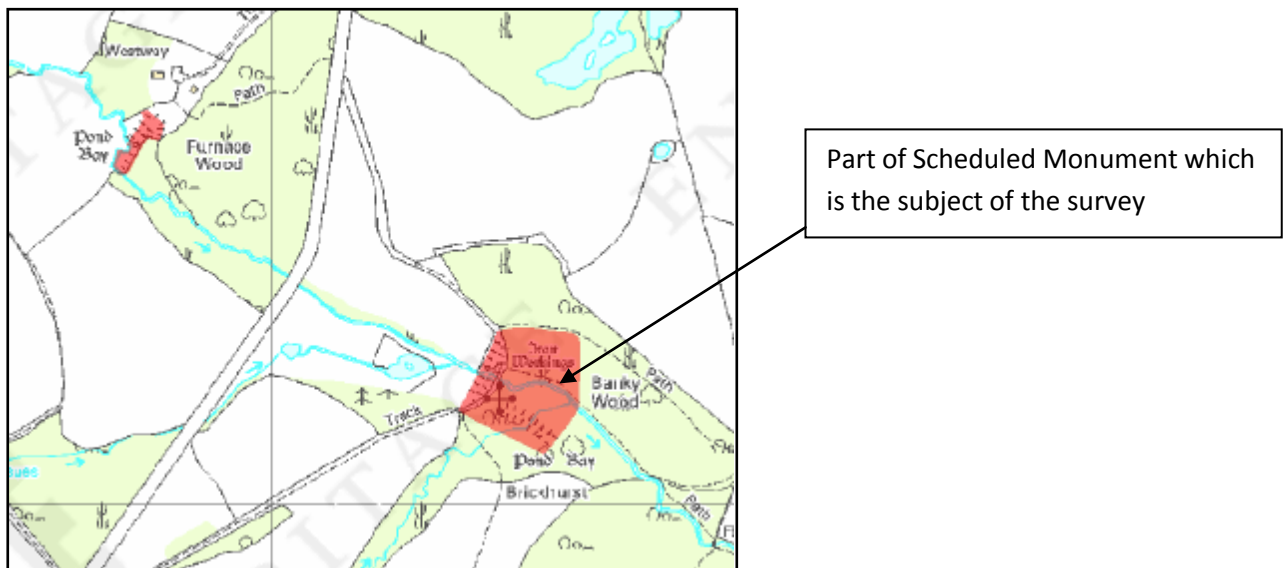
Figure 1. Scheduled Site

The present boundary of the SAM only includes the main centre of the industry together with one pond bay upstream on the edge of Furnace Wood. It does not include the associated features within the wider landscape. [See Figure 1 on page 7].

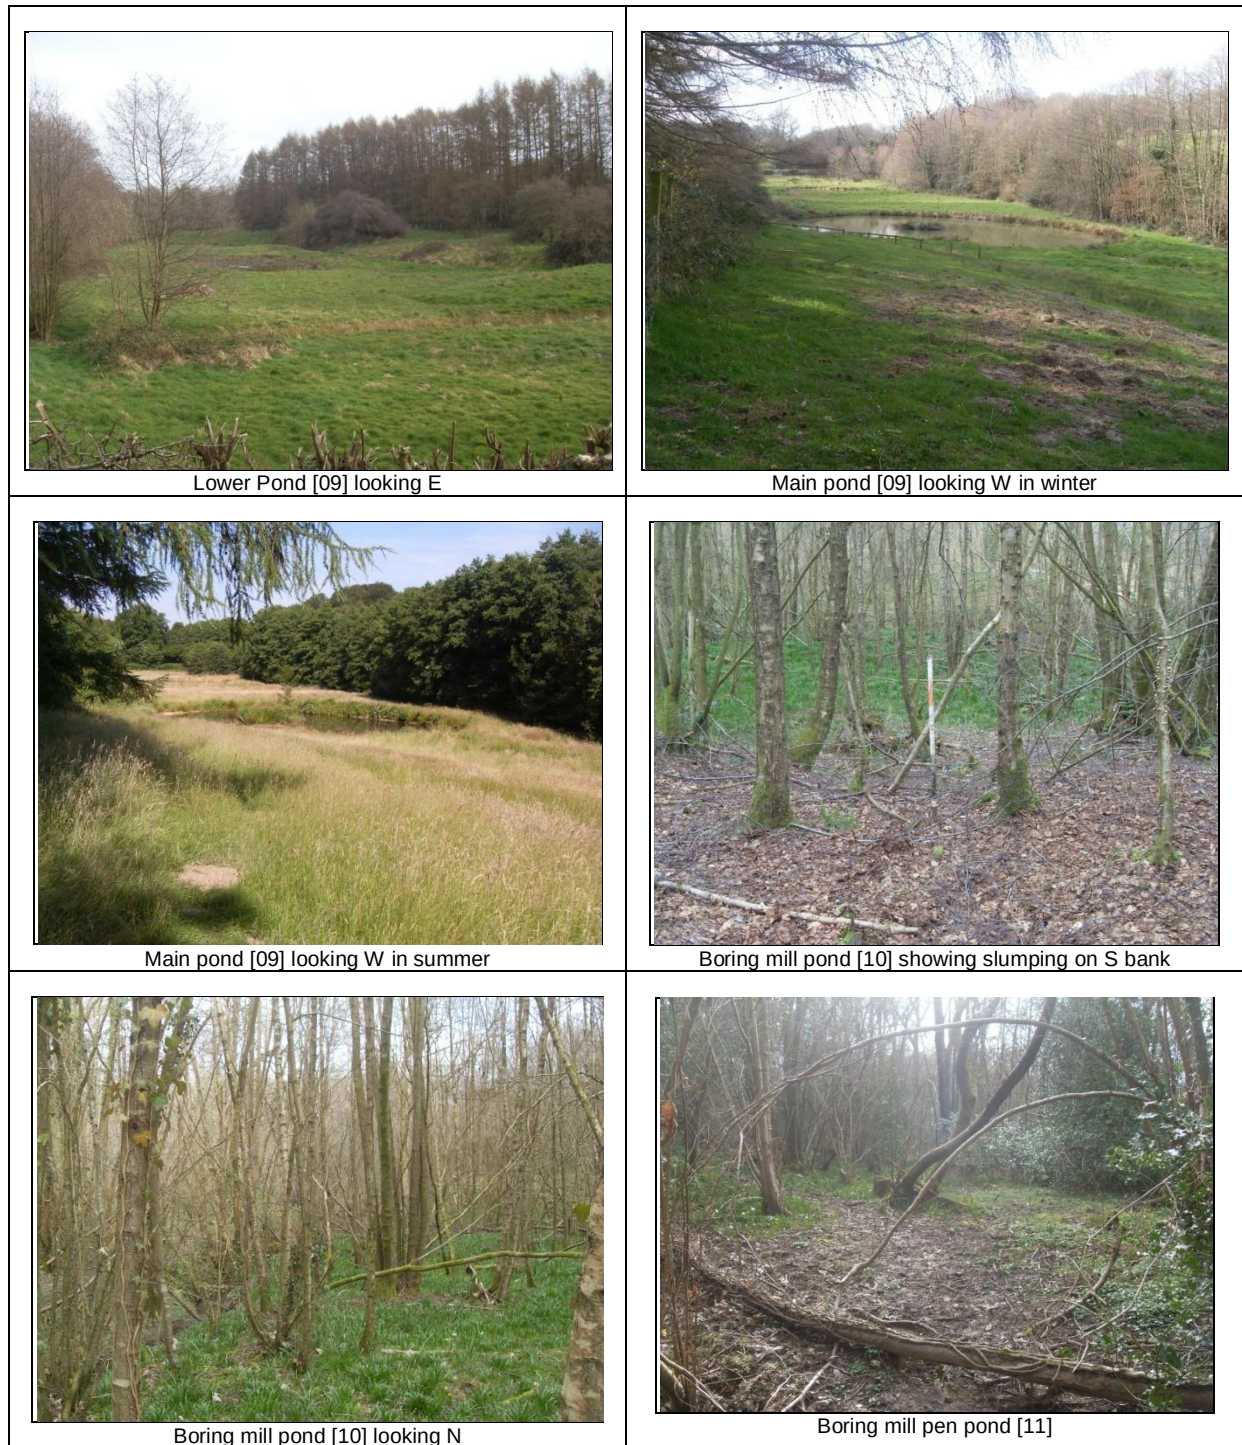
Figure 8. The Ponds [07, 08, 09]

As discussed above the C16 map shows all the main ponds (Figure 3 p15). The upper [07], middle [08] and lower [09] ponds occupy a significant part of the main valley and it is possible to trace their outlines in the valley topography (Map 1a p24). The middle and upper ponds form the main reservoirs for the lower pond. By erecting bays it enabled the flow of water to be controlled through the iron working area. The ponds had been drained by the late C18 as none are shown on the Ordnance Surveyors Draft Drawings for the 1” 1<sup>st</sup> edition (Figure 16 p 56) [OSDs]. The middle pond shows evidence of slumping of the sides of the valley which probably occurred when the pond was drained. The exposed bed rock was subsequently quarried out.

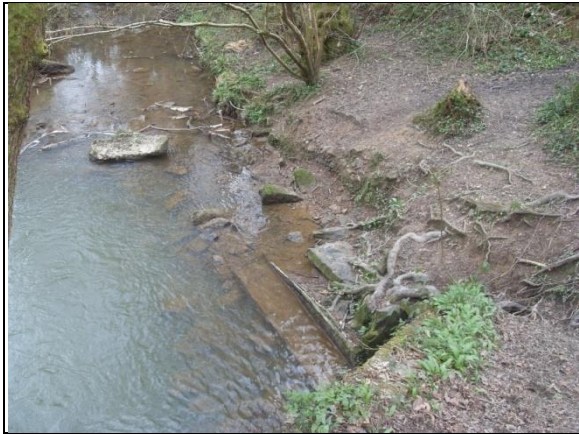
'Bear' and launder in stream

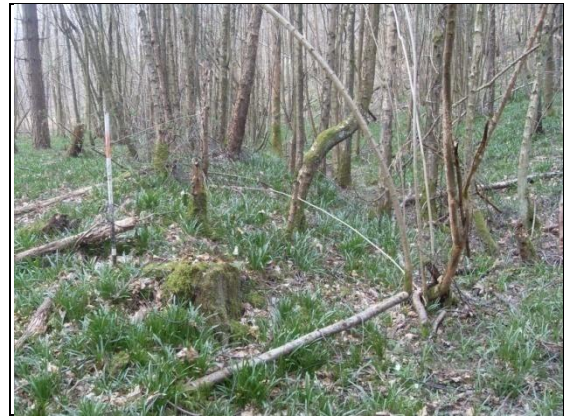
Possible site of forge as recorded by WIRG [30]
